Manhole Inspection Summary

Manhole # S290__001MH

Insp Date: **4/13/09 11:28 AM**

Location Address: **W CROSS ST**

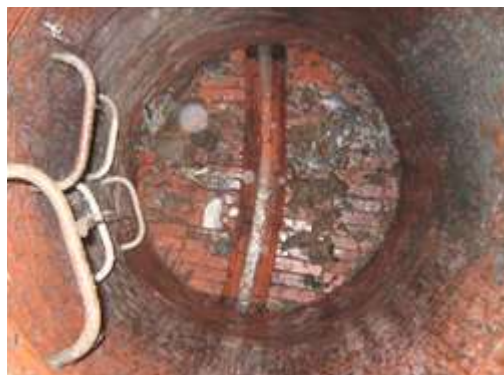
Top View

Frame Offset: **0** (in.) Condition: ☐ Sound ☐ Cracked ☒ **Leaks**

Infiltration: ☐ None ☒ **Joint** ☐ Cracks ☐ Mortar ☐ Roots ☐ Wall
